PIC16(L)F1826/1827 Family Silicon Errata and Data Sheet Clarification

The PIC16(L)F1826/1827 family devices that you have received conform functionally to the current Device Data Sheet (DS41391D), except for the anomalies described in this document.

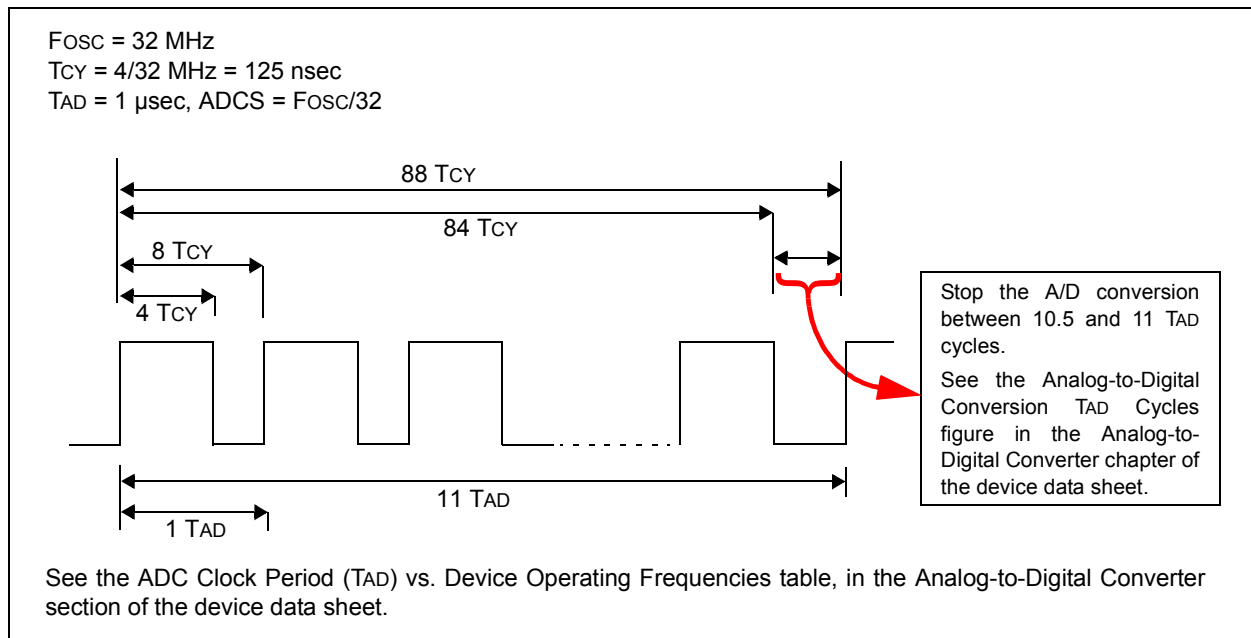
FIGURE 1: INSTRUCTION CYCLE DELAY CALCULATION EXAMPLE

In Figure 1, 88 instruction cycles (T_{CY}) will be required to complete the full conversion. Each TAD cycle consists of eight T_{CY} periods. A fixed delay is provided to stop the A/D conversion after 86 instruction cycles and terminate the conversion at the correct time as shown in the figure above.

Note: The exact delay time will depend on the TAD divisor (ADCS) selection. The Tcy counts shown in the timing diagram above apply to this example only. Refer to [Table 3](#) for the required delay counts for other configurations.

Method 3: This method is provided if the application cannot use Sleep mode and requires continuous operation at frequencies above 8 MHz. This method requires early termination of an ADC conversion. Provide a fixed time delay in software to stop the A-to-D conversion manually, after all ten bits are converted, but before the conversion would complete automatically. The conversion is stopped by clearing the $\overline{GO/DONE}$ bit in software. The $\overline{GO/DONE}$ bit must be cleared during the last $\frac{1}{2}$ TAD cycle, before the conversion would have completed automatically. Refer to Figure 1 for details.
